# 市立ヴェルケ・メディジチ博物館（チェコ）近江八景蒔絵香棚〔修復報告〕

# 近江八景蒔絵香棚 (市立ヴェルケ・メディジチ博物館)

*Pair of Shelves for Incense*  
(Museum Velké Meziříčí)

修復品名	近江八景蒔絵香棚
所蔵	市立ヴェルケ・メディジチ博物館（チェコ）
寸法（cm）	30.6 × 11.6 × 30.7（棚1基分）
修復期間	2年
修復場所	東京文化財研究所 漆修復アトリエ

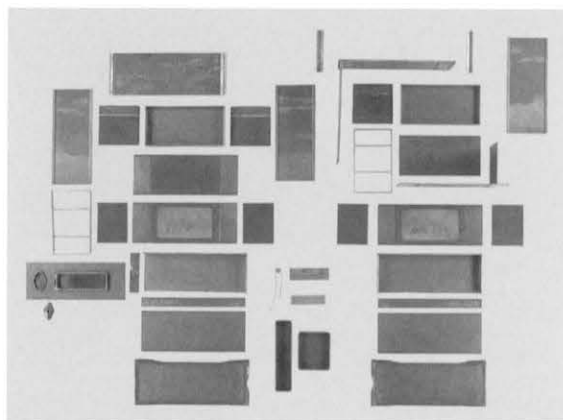
図1 修復前(表面)  
Fig. 1 Before restoration (front face)

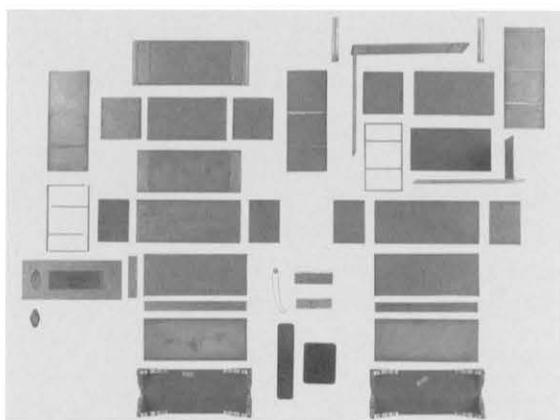
図2 修復前(裏面)  
Fig. 2 Before restoration (back face)

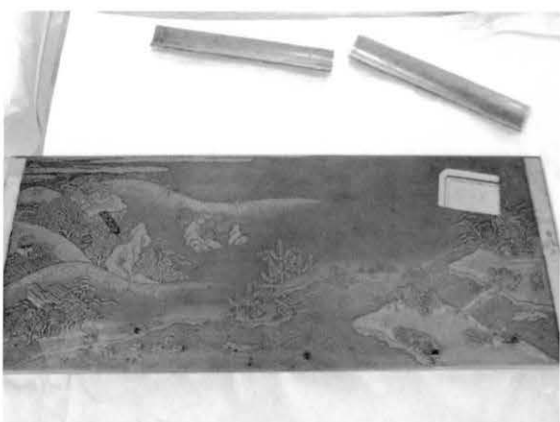
図4 修復前 天板部分  
Fig. 4 Before restoration, top board

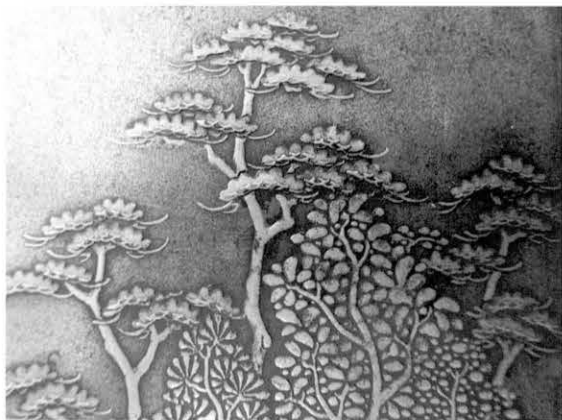
本資料は、ヨーロッパでの修復の際に塗料が塗られ、紫外線や経年変化により塗料が劣化していた。また、塗られた塗料が高蒔絵などの際に溜まり、黒ずんでいた。塗料の除去に使用する溶剤は充分テストを行い適切な溶剤を選択した。結果、エタノールに蒸留水を混合した溶剤で塗料除去を行った。

図11 後補塗料の溜まり  
Fig. 11 Coating material of a past restoration that has accumulated

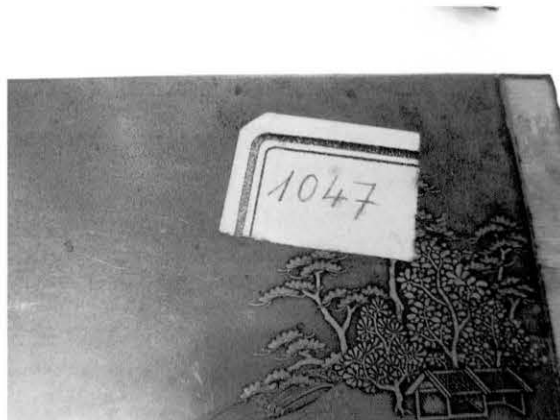
図12 天板に貼られたラベル  
Fig. 12 Label attached to the top board

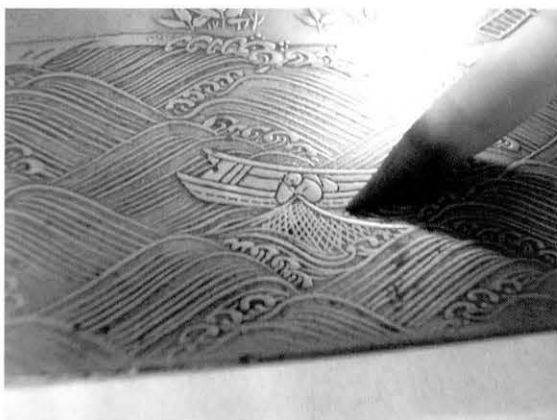
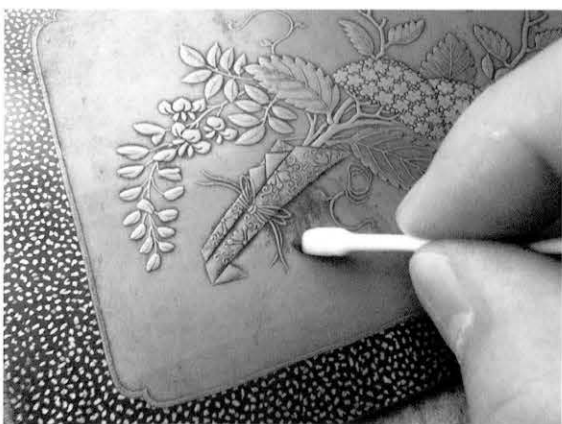
図14 後補塗料の除去  
Fig. 14 Removing coating material of a past restoration

図15 塗料除去  
Fig. 15 Removing the coating material

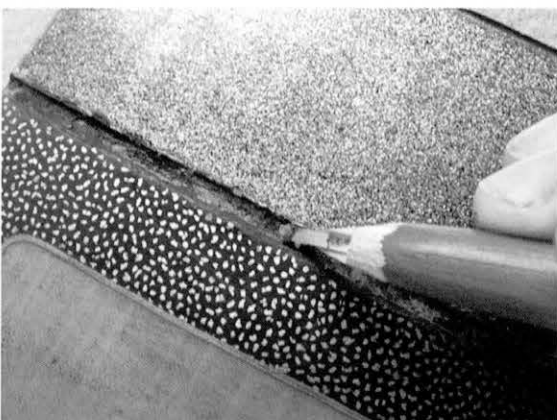
図18 後補接着剤 除去  
Fig. 18 Removal of the adhesive agent of a past restoration

また、各部材の接合部の接着剤は膠が使われていたため、水分を含ませ膨潤させて竹の篋や刃物で丁寧に除去した。

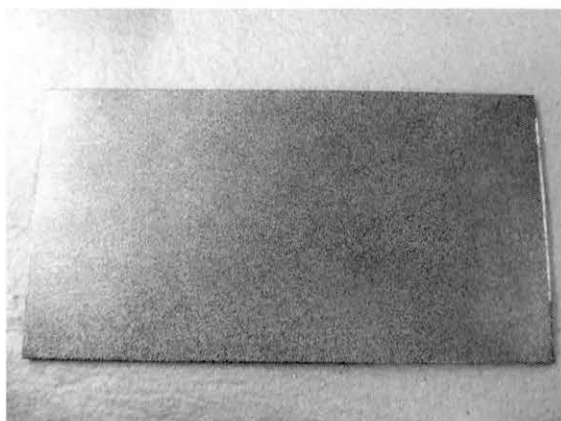
図34 復元棚板 完成

新補する板の素地は、本資料に使われた素材と同じヒノキ材とし、漆下地を施し銀梨子地の仕上げとした。梨子地に使う銀梨子地粉は現在の蒔絵粉を使用するため、号数の違う蒔絵粉を使い梨子地のテスト手板を制作し判断した。尚、新補板の側面の消粉蒔絵部分は、新たな部分が目立ってしまう恐れと後補である証として、所蔵博物館の担当者や東京文化財研究所の担当者と協議した結果、消粉蒔絵の復元は行わず現状の黒漆塗りとした。

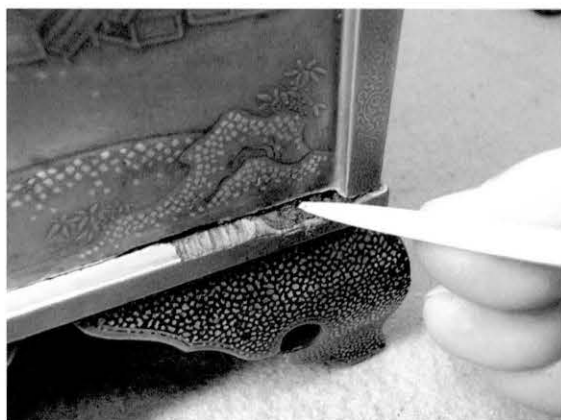
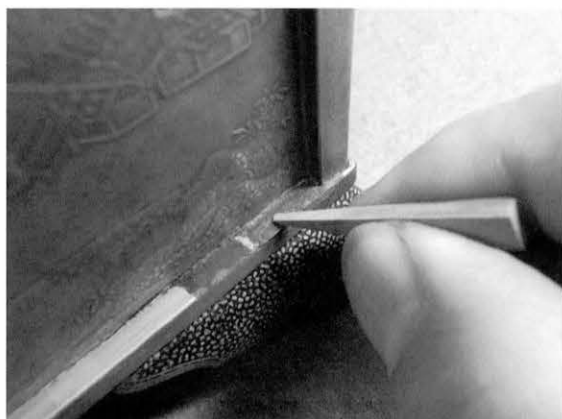
図36 刻字付け

図37 刻字付け部分 研ぎ

亀裂部分の戻しきれない隙間や塗膜の欠損部分には、麦漆に木粉や麻の繊維を混入した刻苧を充填し形態を復元した。刻苧の充填は必要に応じて木粉などの荒さを変えて数回に分けて行った。

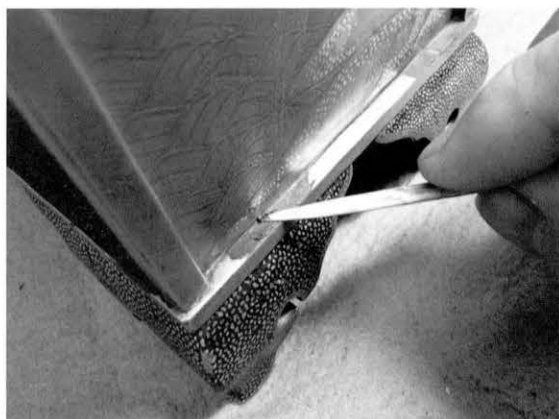
図38 際錆付け

欠損した塗膜や刻苧で充填した亀裂部分に、生正味漆に珪藻土を炭化した微粒子の地の粉を施し再剥落の防止とした。蒔絵部分の仕上げは、梨子地漆に細かな金粉と石粉を混ぜて作った金錆を施し目立たないようにした。

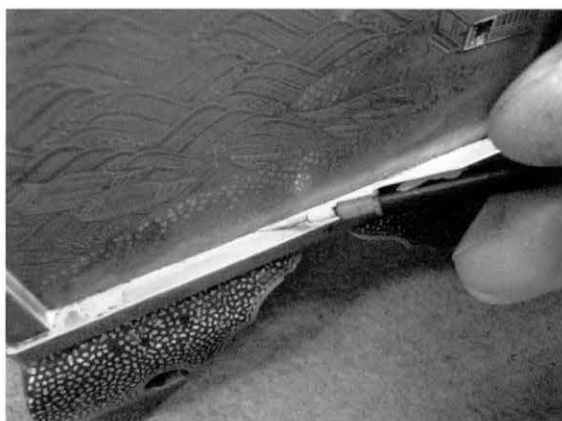
図39 金錆付け
